Final Report No. 2308

by the Swiss Transportation Safety Investigation Board STSB

concerning the accident involving the
Fairchild 24R46A “Argus III” aircraft,
registration HB-ERO,

on 23 August 2016

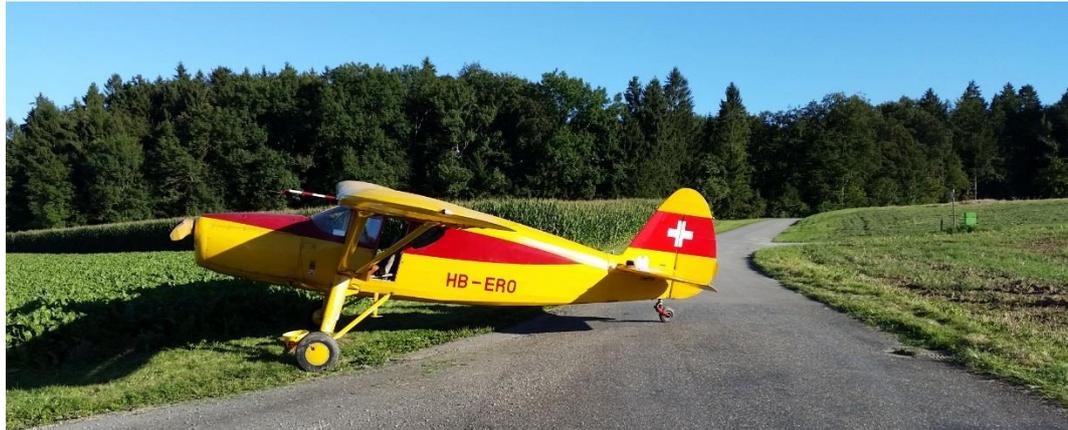
The pilot immediately searched for a suitable forced landing site and decided to land HB-ERO on uncultivated farmland near Weiler Oberhöhnwilen in a south-easterly direction. The two occupants were uninjured during the landing and the aircraft was not further damaged.

Figure 2: Aircraft HB-ERO after the forced landing near Oberhöhnwilen

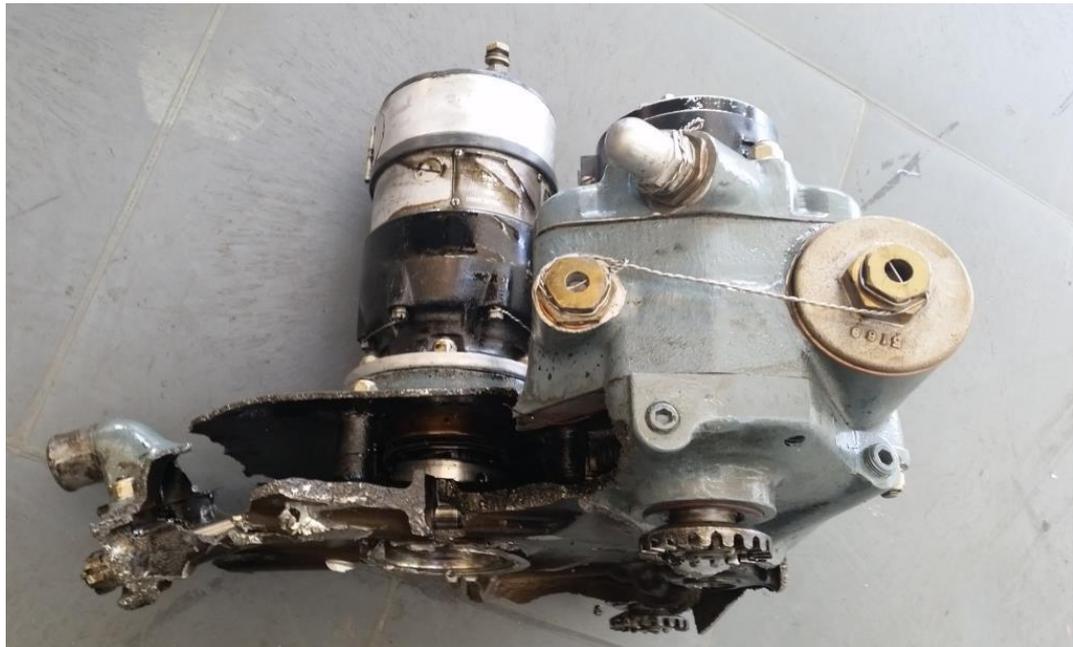
- The aircraft did not exhibit any signs of external damage and the controls functioned perfectly.
- The flaps were retracted.
- All electrical switches and the magnetos were switched off and the fuel cocks were closed.
- Engine oil was dripping out at the transition from the lower engine cowling to the airframe. The right and lower engine cowling as well as the front half of the underside of the aircraft were heavily contaminated with oil.
- After disassembly of the lateral engine covers, it was found that the crankcase was fractured towards the rear of the engine.
- Various components were found on the lower engine cover, among other things crankshaft counterweights and fragments of the engine housing.
- The accessory section as well as the two magnetos had become separated from the engine (cf. Figure 3).

Figure 3: The accessory section and the two magnetos were separated from the engine of HB-ERO.

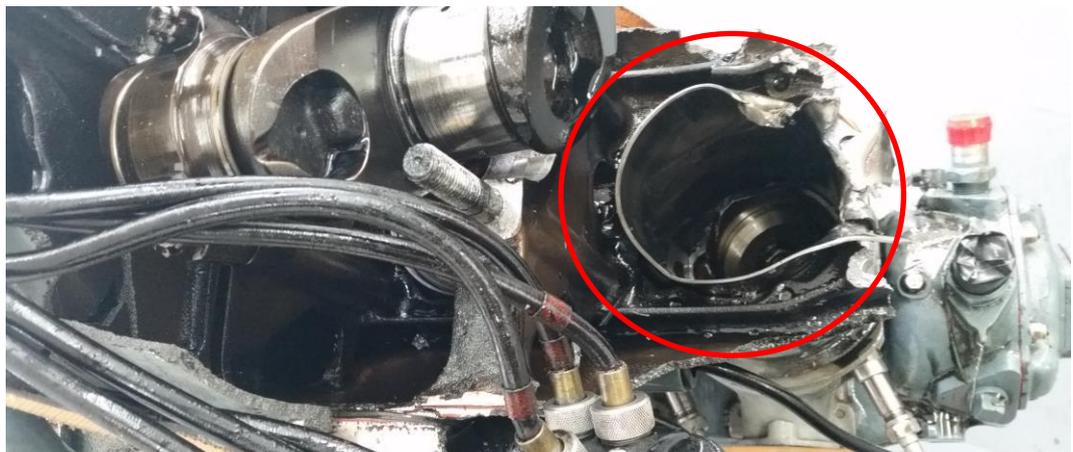
- The rearmost cylinder no. 1, viewed in the direction of flight, as well as its piston and the associated part of the housing, were destroyed; the crankshaft was broken and the camshaft was bent.
- The piston rod was bent through approximately 160 degrees.
- The crankcase was destroyed as far as cylinder no. 3.
- Except for the front right engine mount, all mounts were separated from the engine housing.

Figure 4: The components of cylinder no. 1 (marked in red), the rearmost cylinder viewed in the direction of flight, were destroyed.

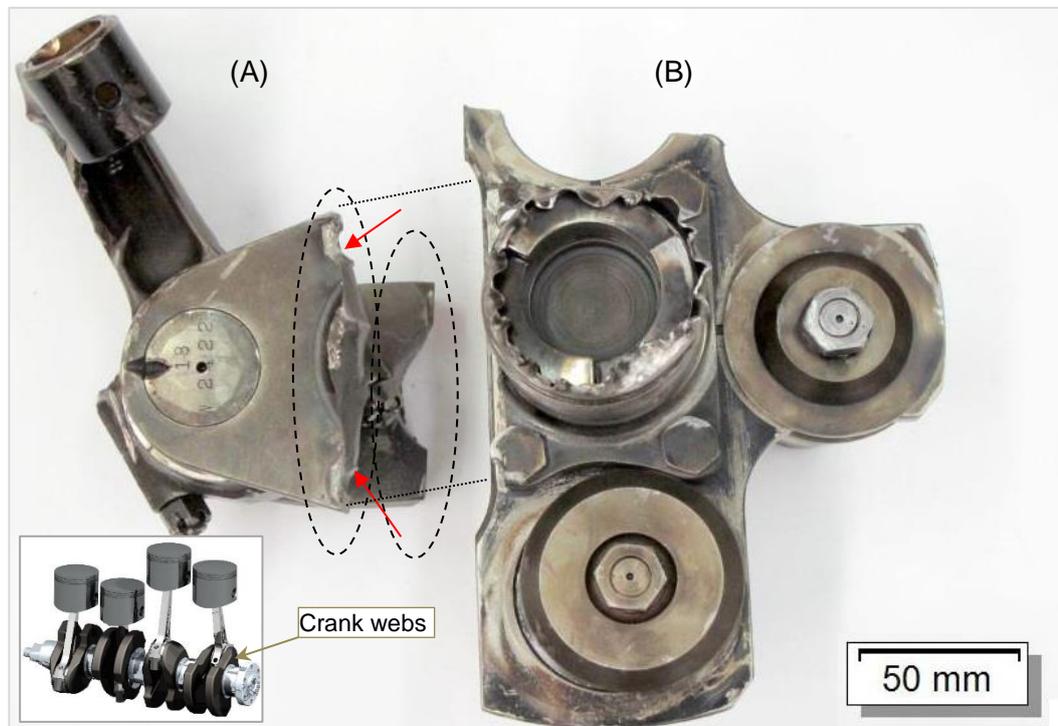
- Crankpin no. 1 with piston rod and broken-off crankshaft webs (A);
- Separated section of the crankshaft (B).

Figure 5: Part (A) with the two broken-off crankshaft webs (marked by broken lines) and part (B) of the engine of HB-ERO for metallographic investigation of the fracture surfaces (red arrows)

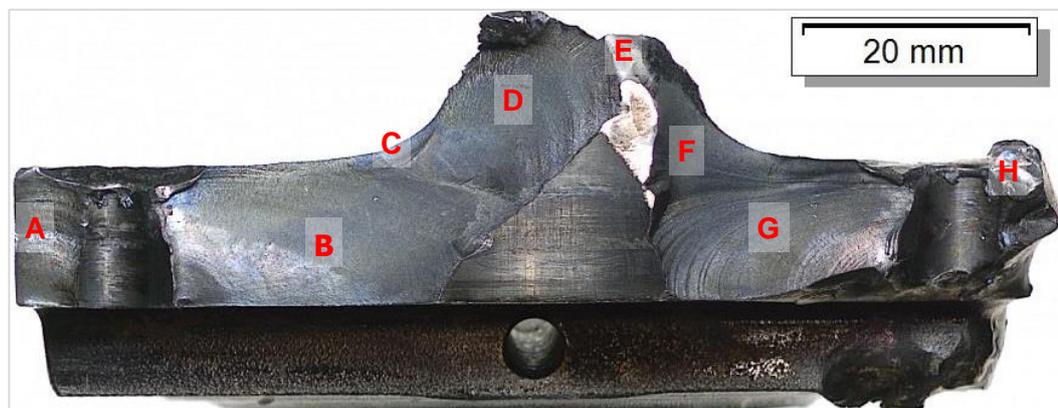
In terms of the material, no characteristics relating to the cause of the fracture were found. Owing to the secondary damage caused by the reciprocal friction of the fracture surfaces, the fractures could no longer be clearly interpreted microfractographically. Nevertheless, there were indications of various fatigue failure zones (cf. Figure 6 Zones A, B, C, D and G are fatigue fracture surfaces which exhibit clear striations. It was not possible to analyse fracture zone H due to mechanical damage.

Figure 6: Fracture surface of the crankshaft web with the fatigue fracture surfaces in zones A, B, C, D and G (from left to right); it was not possible to analyse fracture zone H.

The fatigue fractures found by metallographic examination (cf. section 1.5.2) were initiated over a fairly long time at different points on a crankshaft web of rear cylinder no. 1. The residual fracture surface was small, which in normal operation suggests a low load on the crankshaft web.

It cannot therefore be completely excluded that the cracking at the crankshaft occurred since the engine was first put into service. It can be assumed with a high degree of probability that a crack was present at the time of the last total overhaul of the engine in 2005 at 2716:39 hours TSN. Such cracks usually are detected on the occasion of a crack test as part of a total overhaul.

This pre-existing weakening was the cause of the sudden fracture of the crankshaft webs of the rearmost cylinder, viewed in the direction of flight, whilst cruising with a normal load on the engine, leading to the engine immediately seizing up and to serious damage to the engine. The slightly increased oil temperature when cruising, as well as the engine's increased oil consumption, do not provide a plausible explanation in respect of an existing connection with the pre-existing damage at the crankshaft.
