Final Report No. 2308

by the Swiss Transportation Safety Investigation Board STSB

concerning the accident involving the
Fairchild 24R46A “Argus III” aircraft,
registration HB-ERO,

on 23 August 2016

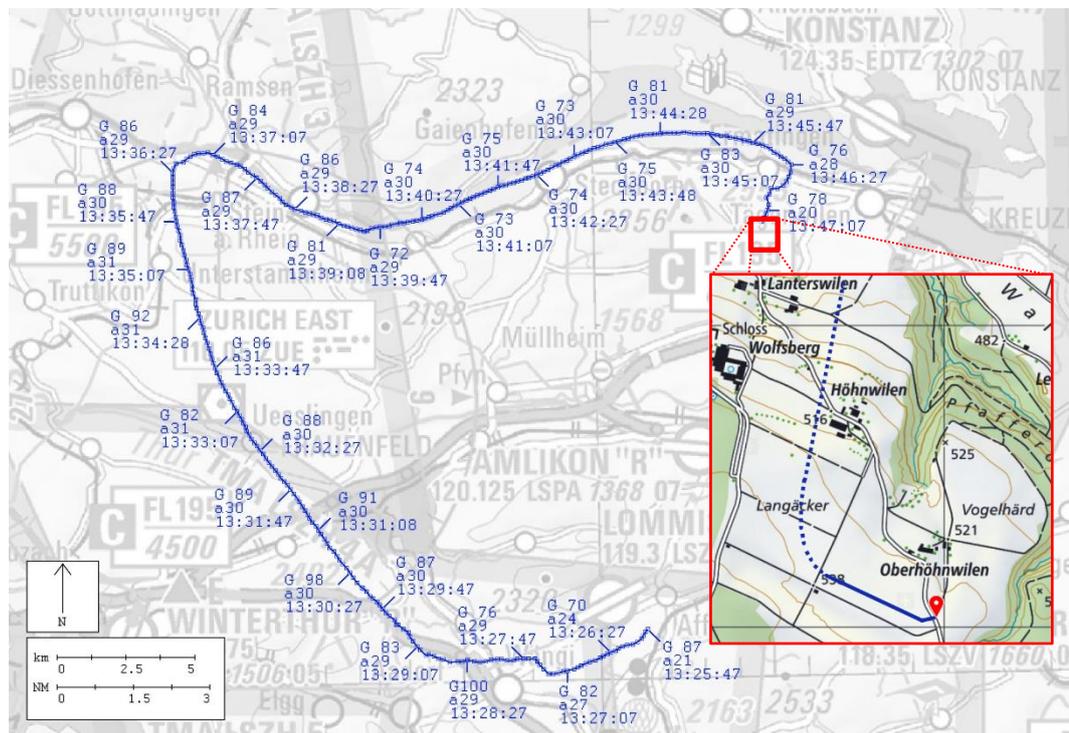
Figure 1: Flight path of HB-ERO after take-off from runway 06 in Lommis (LSZT) according to radar recordings until the forced landing near Oberhöhnwilen, municipality of Ermatingen/TG (red rectangle with approximate flight path and landing direction) on obstacle-free farmland with information on ground speed (G) in knots, altitude (A) in hundreds of feet QNH and time in UTC, base map reproduced with the consent of Swisstopo, the Federal Office of Topography (JA150149).
